TB AIRCRAFT SERVICE BULLETIN N° 29

SUBJECT : STABILATOR CONTROL ROD

VALIDITY : All TB aircraft serial numbers 1 to 709 except numbers 652, 653, 661, 664, 665, 672, 691, 701 to 706.

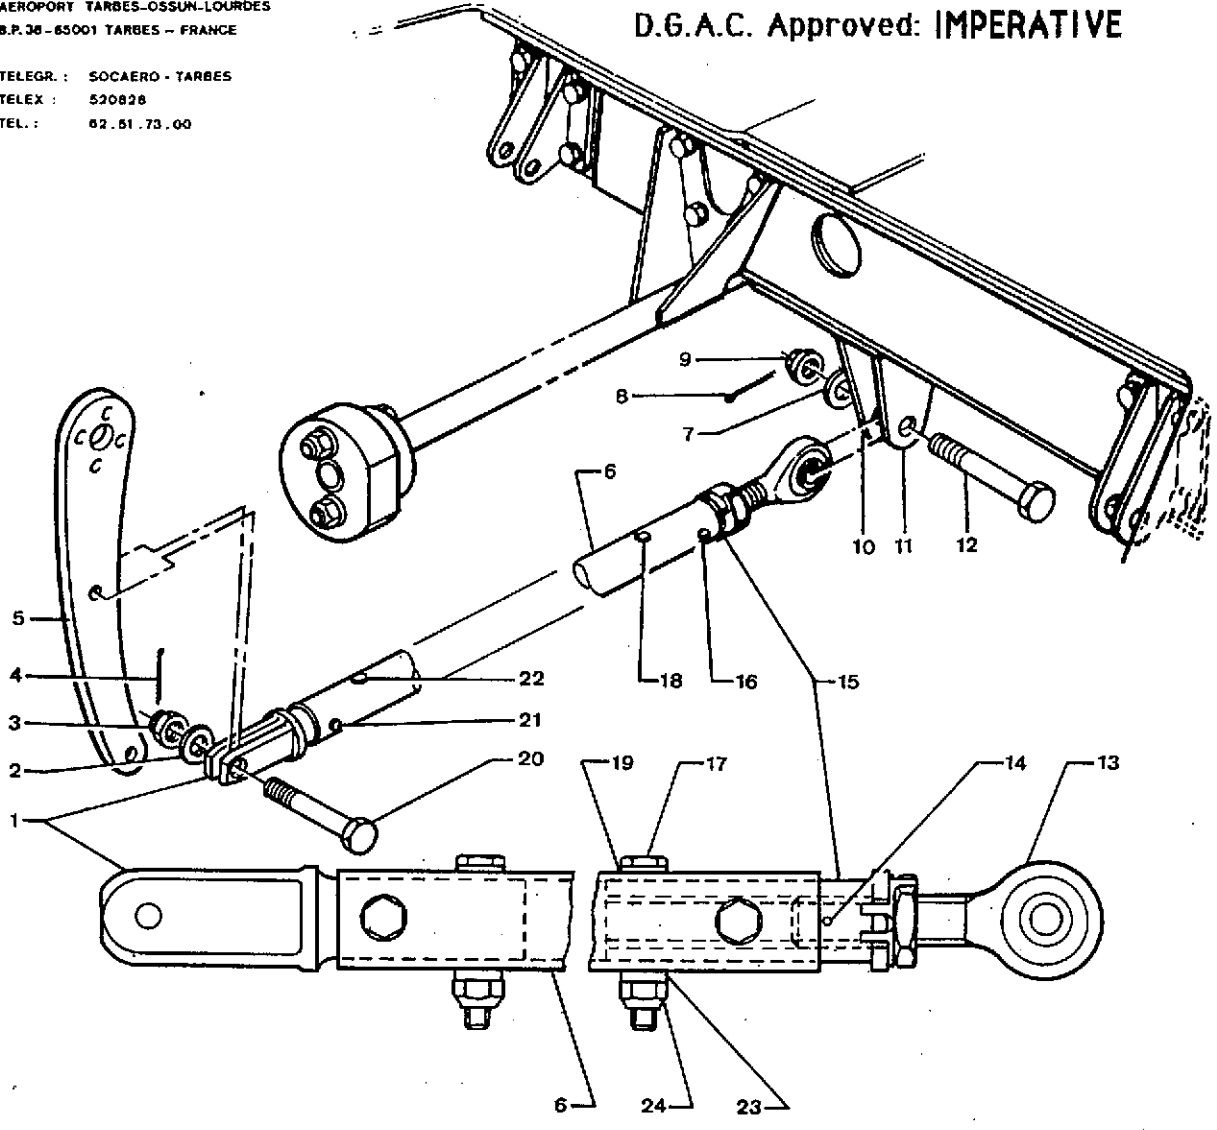
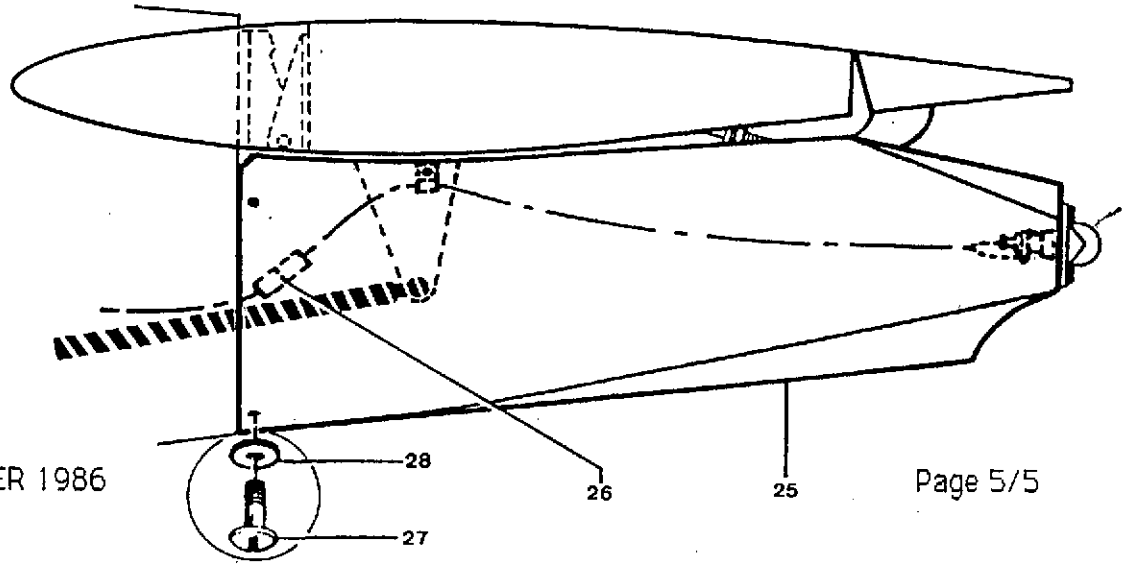
PURPOSE : Some cases of play at the location of stabilator actuating rod ends riveting having been found, this involves a particular inspection on the aircraft in operation.
From aircraft serial Nr 710 and numbers 652, 653, 661, 664, 665, 672, 691, 701 to 706 the riveting has been replaced by an assembly with screws, washers, nuts.

- Remove the rear cone assy (Item 25), retain the screws and attachment washers (Items 27 and 28), disconnect the rear lighting wirings (Item 26).
- Check (if necessary with a gauge) the rivets condition (Items 16, 18, 21 and 22) attaching the threaded end (Item 15) and the clevis end (Item 1) on the stabilator actuating rod tube (Item 6).

- Disconnect the actuating rod (Item 6) from levers (Items 5, 10 and 11), retain the screws (Items 20, 12) washers (Items 2, 7) nut (Item 3) thin nut (Item 9) discard pins (Items 4, 8)
- Remove the extreme rivets (Items 16 and 21) with a diameter 4 mm drill.
- Drill back the holes to diameter 4.8 mm (going through and through the rod).
- Bore these holes to diameter 5 mm (+ 0 ; + 0,1).
- Deburr.
- Install temporarily the 2 screws (Item 17), the 2 washers (Item 19), the 2 washers (Item 23), the 2 nuts (Item 24).
- Remove the internal rivets (Items 18 and 22) with a 4 mm drill.
- Drill back the holes to diameter 4.8 mm (going through and through the rod).

- Bore these holes to diameter 5 mm (+ 0 ; + 0,1).
- Deburr.
- Note the location of ends (Items 1 and 15) with regard to tube (Item 6) with adhesive tape or ink felt.

- Remove the attachments (Items 17, 19, 23 and 24).
- Remove the ends, deburr them, clean them as well as the tube.
- Re-install the ends on the tube, install the 4 screws Z00.5010.2.05.225 or L 22201.50.22 BCL (Item 17), the 4 standard washers Z00.5200.1.05.000 (Item 19), the 4 semi-thick washers Z00.5203.7.05.000 (Item 23) then the 4 locknuts Z00.5320.1.05.000 (Item 24). Lubrication see Chapter II.11 of Maintenance Manual, tightening torque of nuts (Item 24) 0,25 m.daN (21.5 inch. Pound).

- Re-connect the actuating rod with screws (Items 20 and 12) washers (Items 2 and 7) nut (Item 3) thin nut (Item 9).
- Check the operation and the deflection of stabilator control and of tab see Chapter V.1 and V.5 of Maintenance Manual.
